# PROBLEMS, CAUSES AND CURES

OF HARDWOOD FLOORS

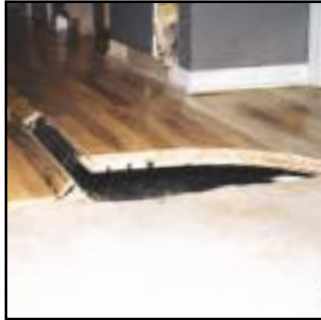
## Buckling

What it is:  
The wood flooring becomes separated from the subfloor. It usually is accompanied by cupping and swelling.

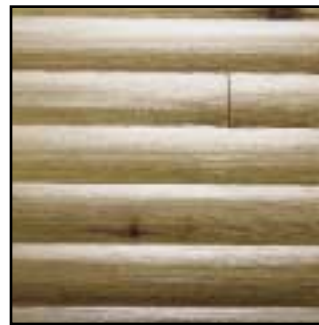
## Crowning

The center of the pieces of flooring appears to be higher than the edges.

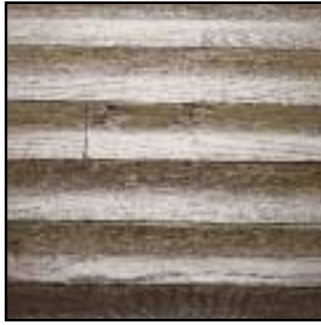
## Cupping

**What it is:**  
Cupping occurs across the width of the individual pieces of flooring. The edges are high and the center is lower. It generally develops gradually.

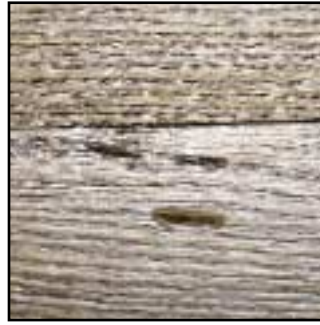
## Dents

**What it is:**  
A crushed spot in the wood.

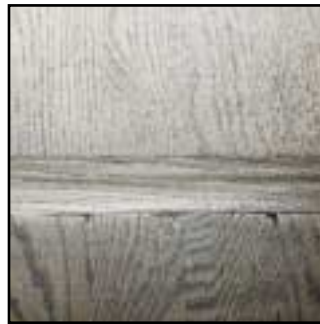
## Dish Out

**What it is:**  
Areas on the wood floor where softer parts of the wood appear to have been sanded more than other areas. Occurs between areas of annual rings (see also “Shellout/Dishing of Springwood” on page 9) or between mixed

species of varying hardness together on a floor, such as in feature strips, borders and medallions.

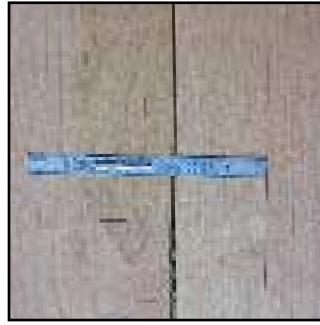
## Gaps, Abnormal

Gaps in the floor that remain with seasonal change. If some boards appear glued together by the surface finish, see “Sidebonding/Panelization” on page 14.

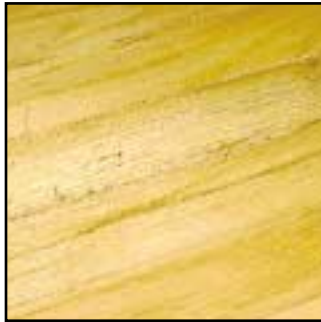
## Insects

A sagging surface or small fresh holes surrounded by white powder in the surface of the flooring.

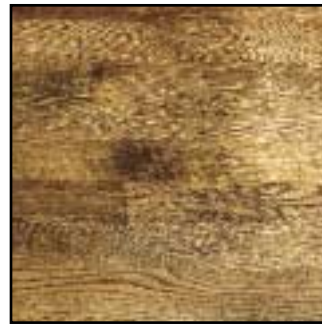
## Picture Framing ("Halo")

The edges of the room appear to be a slightly different color than the rest of the room.

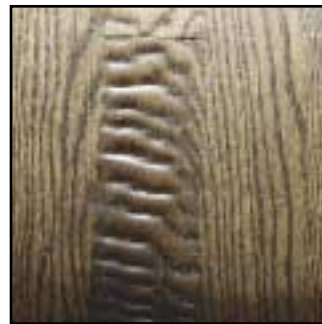
## Shellout/Dishing of Springwood

Uneven wear between segments of annual rings.

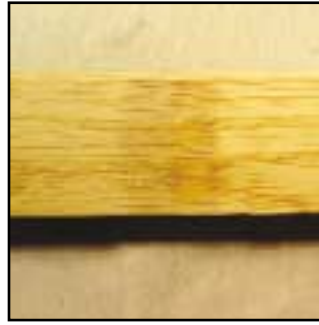
## Sticker Stain

Light brown marks that appear on the wood surface, especially on maple, ash or other light woods. They occur across the width of the strip, measure  $\frac{3}{4}$  to 1 inch wide and occur about every 20 to 24 inches down the length of

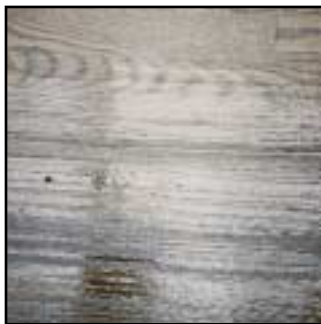
## Applicator Streaks

After the floor dries, marks still are visible from the path of the applicator. It usually is associated more with water-based finishes than other types of finishes, although it may affect other types, as well.

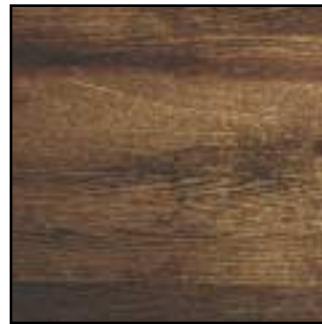
## Bleed Back

Occurs when excess stain seeps up from the grain or from the spaces between boards.

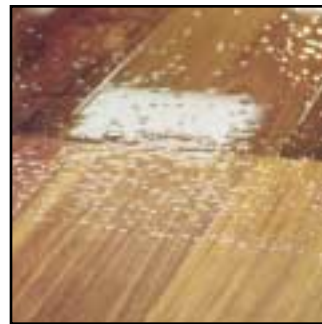
## Bubbles

Dried bubbles are visible on the surface of the finish.

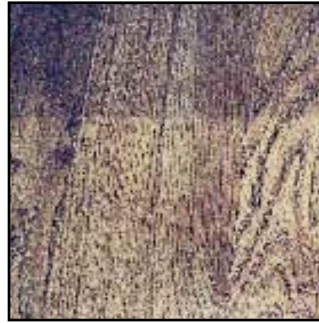
## Discoloration

**What it is:**  
The floor changes color over time. Some areas may darken more than others.

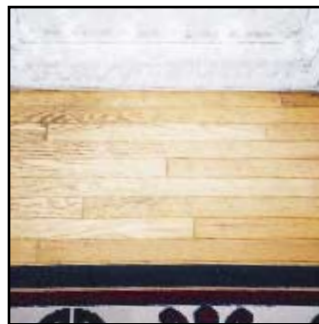
## Excessive/Early Finish Wear

**What it is:**  
The appearance of too much wear on a relatively new finish.

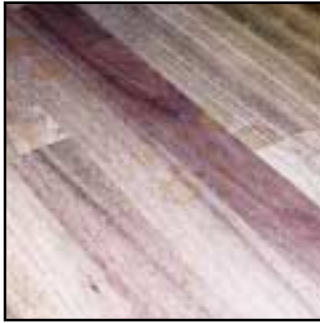
## Fisheyes/Crawling

**What it is:**  
A circular, cloudy haze with a clear center. They can measure up to about 1 inch in diameter.

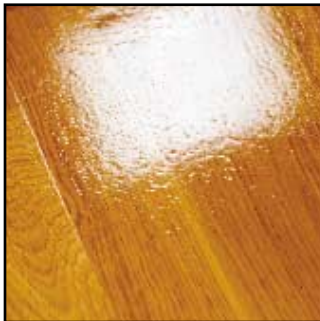
## Orange Peel

**What it is:**  
The surface of the finish has a texture that resembles an orange peel.

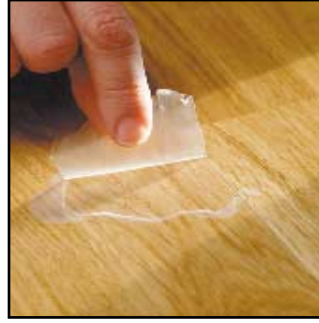
## Peeling

**What it is:**  
The finish delaminates from the floor in sheets.

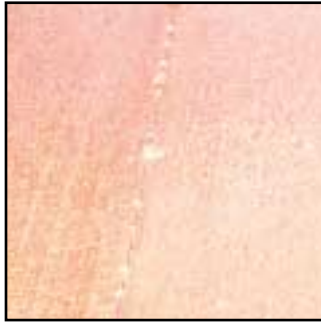
## Poly Beads

**What it is:**  
Droplets (“BB’s”) of finish that form along strip edges. They can be soft and sticky when first formed, but will become quite hard if left undisturbed.

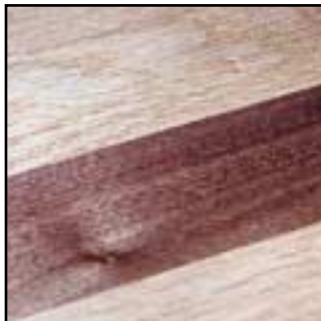
## Roughness/Grain Raise

**What it is:**  
The surface of the wood floor is rough to the touch.

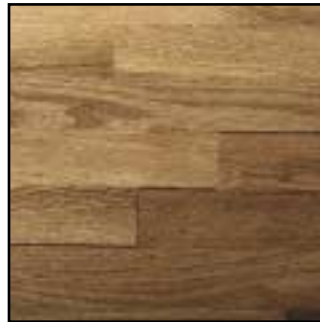
## Sidebonding/Panelization

**What it is:**  
The problems appear similar, but are different. With sidebonding, the bottoms of the edges of the individual strips are “glued” together by the finish. It can occur with all types of finish, although it happens more frequently with water-based products. Panelization occurs when the edges of boards are crushed and stick together as a result.

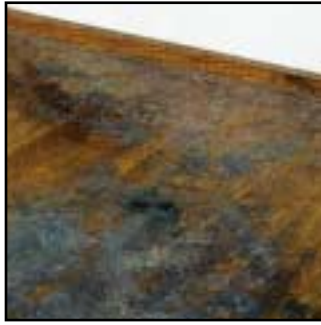
## Stains

**What it is:**  
Discoloration on one area of the floor.

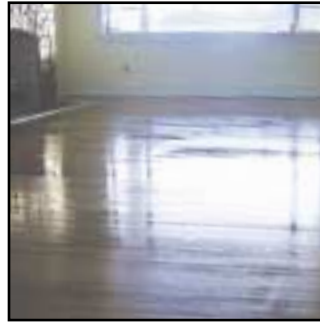
## Uneven Sheen Levels

**What it is:**  
The sheen of the finish is inconsistent.
